REPORT OF INVESTIGATION  
(Underground Coal Mine)

NONINJURY COAL MINE OUTBURST (BOUNCE) ACCIDENT

L. S. Wood Mine (ID No. 05-00300)  
Mid-Continent Resources, Inc.  
Redstone, Pitkin County, Colorado

October 17, 1980

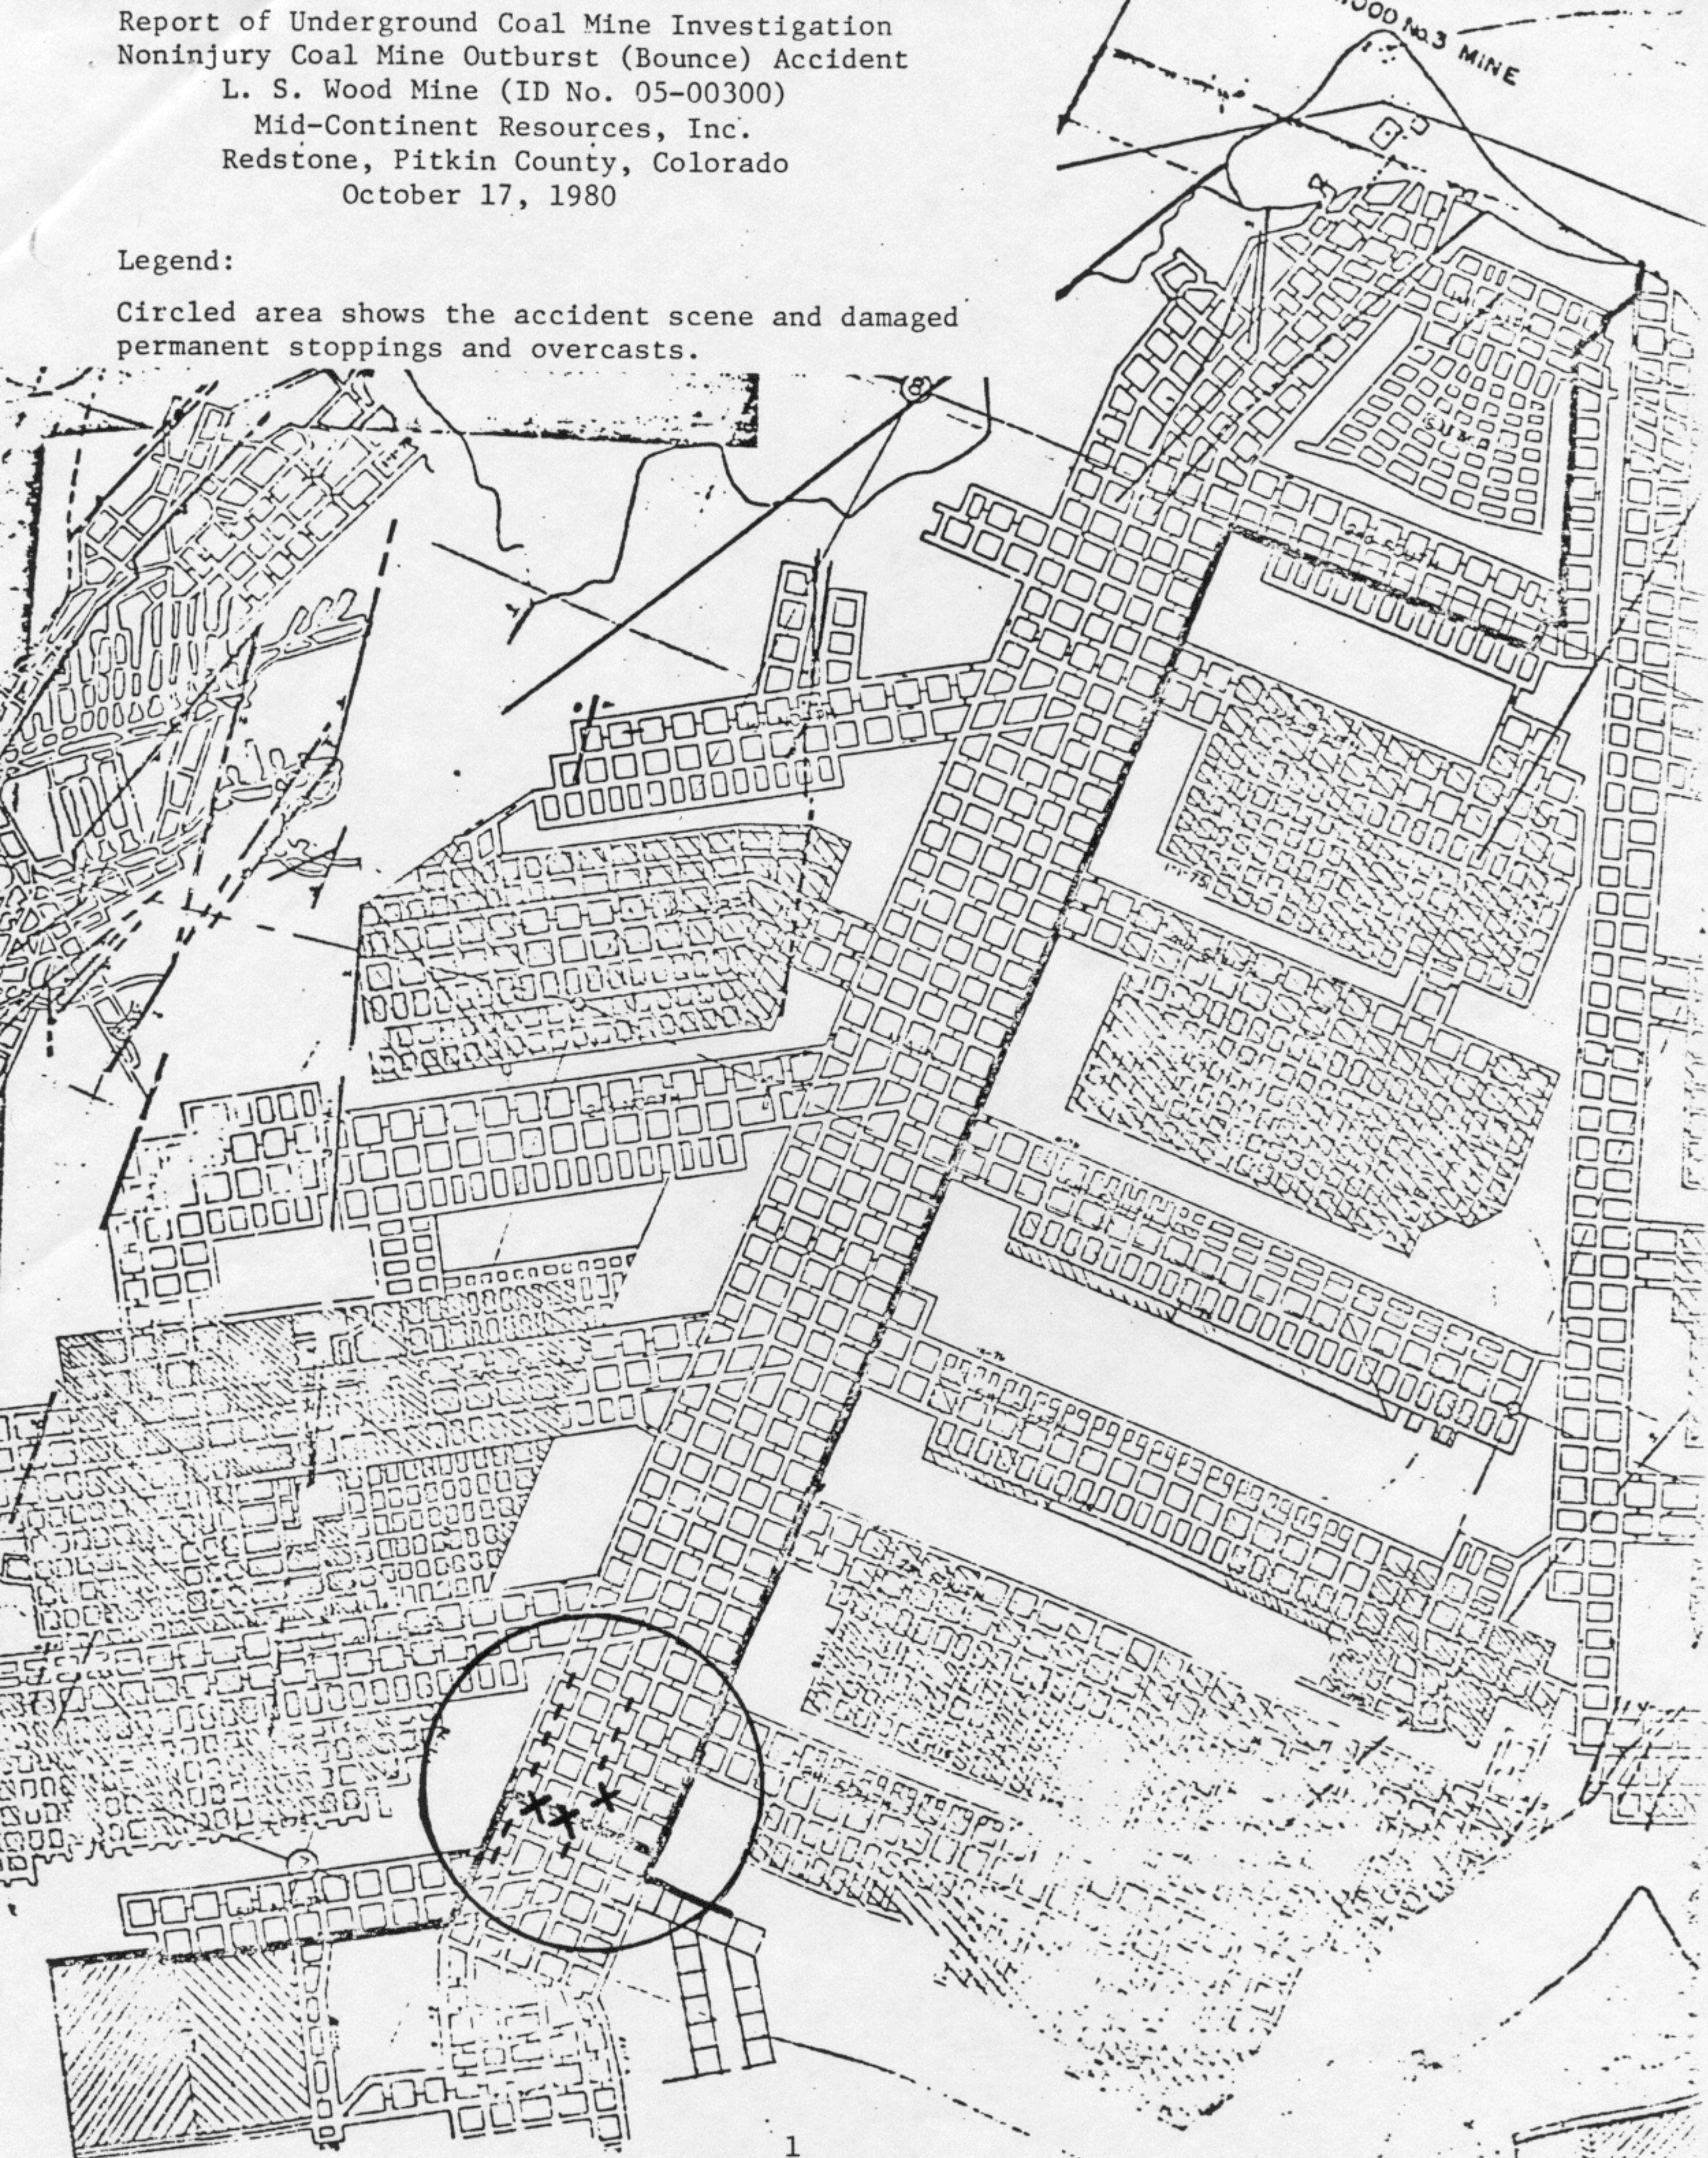
Circled area shows the accident scene and damaged permanent stoppings and overcasts.

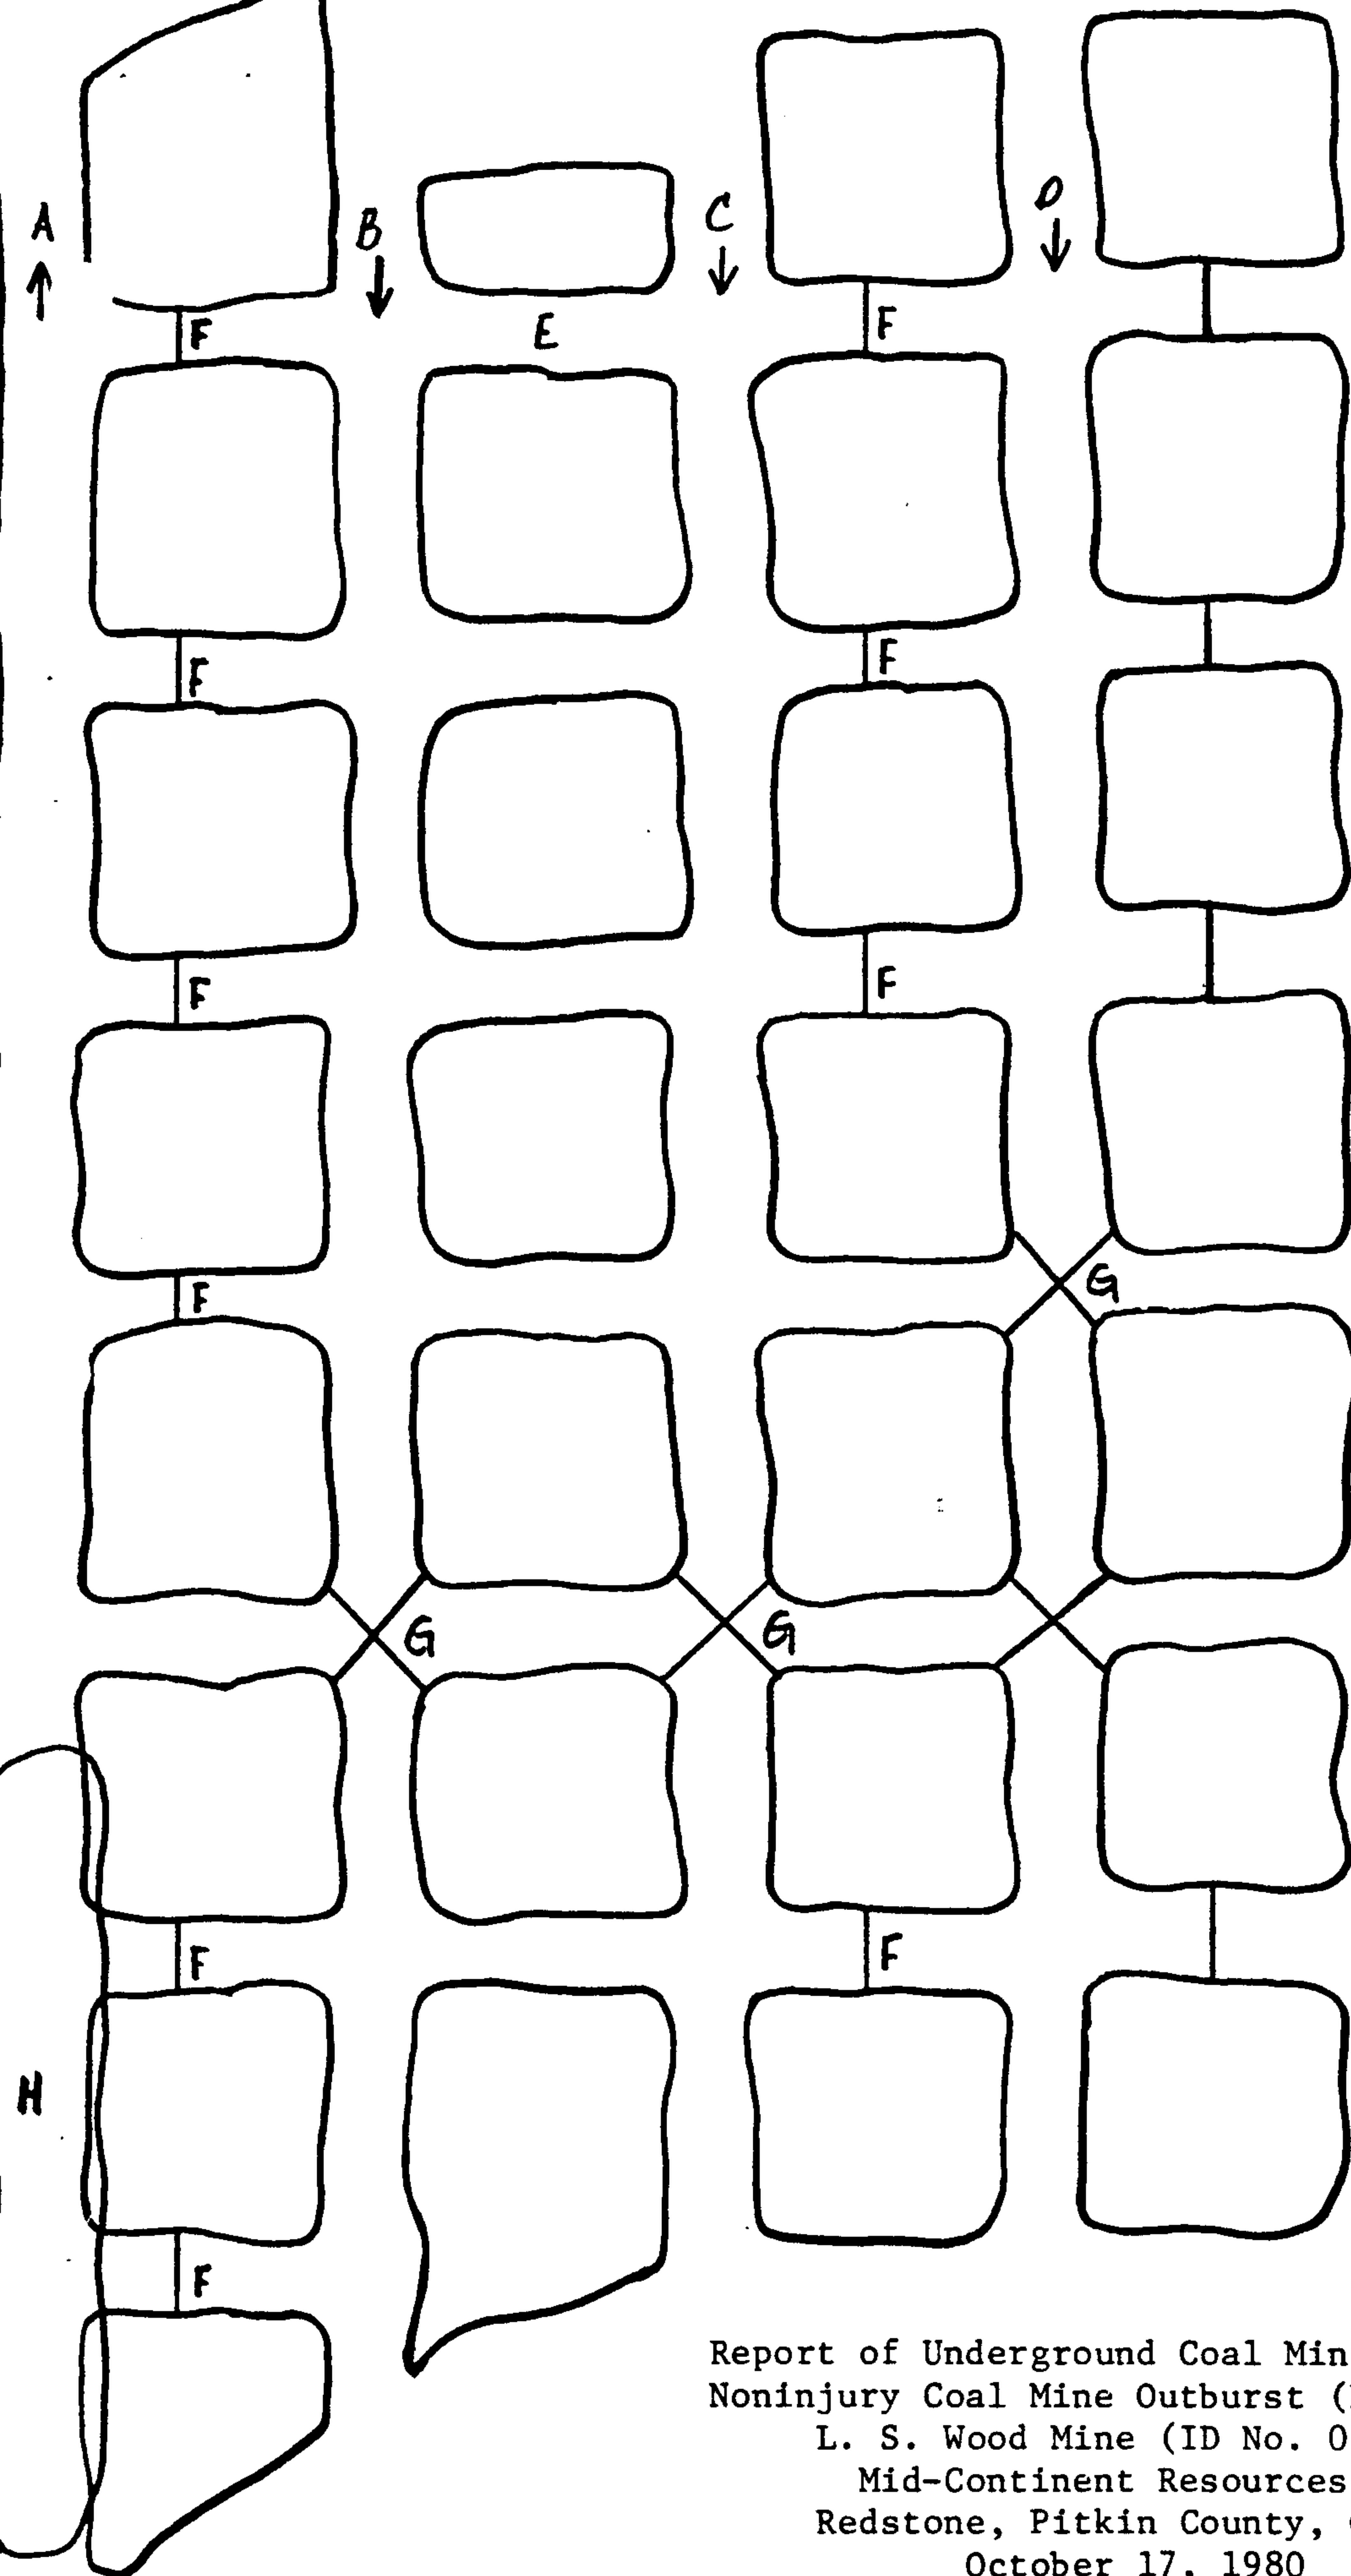
- A - No. 6 slope return air course
- B - No. 5 slope intake air course
- C - No. 4 slope intake air course and track haulage slope
- D - No. 3 slope intake air course and conveyor belt slope
- E - Crosscut No. 54
- F - Damaged permanent stoppings
- G - Damaged overcasts
- H - Area where the damage was the most severe

6. The accident scene extended from crosscut No. 54 to crosscut No. 59 in the No. 3 and No. 4 slopes, a distance of approximately 500 feet and from crosscut No. 54 to crosscut No. 61 in the No. 5 and No. 6 slopes, a distance of approximately 700 feet.

7. The heaviest damage was in the No. 6 slope, the main return air course for the 301-0 longwall active working section. This slope was 6½ to 7 feet in height and 18 to 22 feet in width prior to the outburst. After the outburst the slope measured 16 inches to 5 feet in height and up to 32 feet 6 inches in width.

8. Thirteen permanent ventilating devices were either destroyed or damaged by the coal outburst.
9. According to the night shift mine examiner's on-shift report on October 17, 1980, a .9% volume of methane gas was detected after the coal outburst in the No. 6 slope.

According to Charles Dominguez, night shift mine foreman, the task of rebuilding and repairing the damaged stoppings and overcasts was begun shortly after the outburst occurred, continued through the weekend, and was completed between 7:00 and 7:30 p.m. on October 20, 1980.
